# Transmission Bearing Damage Detection Using Decision Fusion Analysis

Paula J. Dempsey  
Glenn Research Center, Cleveland, Ohio

David G. Lewicki and Harry J. Decker  
U.S. Army Research Laboratory, Glenn Research Center, Cleveland, Ohio

A diagnostic tool was developed for detecting fatigue damage to rolling element bearings in an OH-58 main rotor transmission. Two different monitoring technologies, oil debris analysis and vibration, were integrated using data fusion into a health monitoring system for detecting bearing surface fatigue pitting damage. This integrated system showed improved detection and decision-making capabilities as compared to using individual monitoring technologies. This diagnostic tool was evaluated by collecting vibration and oil debris data from tests performed in the NASA Glenn 500 hp Helicopter Transmission Test Stand. Data was collected during experiments performed in this test rig when two unanticipated bearing failures occurred. Results show that combining the vibration and oil debris measurement technologies improves the detection of pitting damage on spiral bevel gears duplex ball bearings and spiral bevel pinion triplex ball bearings in a main ro

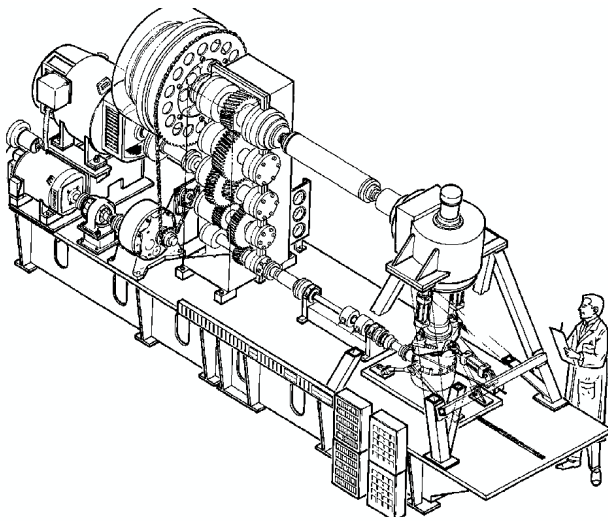
a) Rig Schematic.

Experimental data were recorded from tests performed in the NASA Glenn 500 hp Helicopter Transmission Test Stand as shown in figure 1a and described in detail in reference (Lewicki (1987)). The test stand operates on the closed-loop or torque-regenerative principle. A 200 hp variable-speed direct-current (DC) motor powers the test stand and controls the speed. A 15 hp DC motor provides the torque in the closed loop through use of a magnetic particle clutch and differential gearbox. A mast shaft loading system in the test stand simulates rotor loads imposed on the test transmission output mast shaft. Two vertical load cylinders connected to a loading yoke produce lift loads. One horizontal load cylinder produces bending load.

Figure 1.—500 hp Helicopter Transmission Test Stand.

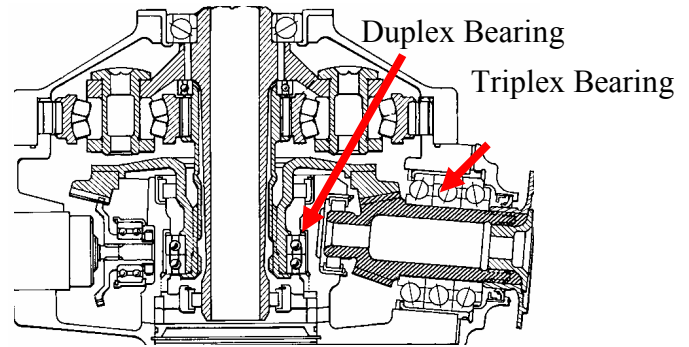
b) OH-58 Main Rotor Transmission.

The test transmission was the OH-58 main rotor transmission (fig. 1b). The design maximum torque and speed for the OH-58A main-rotor transmission is 350 N-m input torque and 6060 rpm input speed (corresponding to 298 hp). The transmission is a two-stage reduction gearbox. The first stage is a spiral bevel gear set with a 19-tooth pinion that meshes with a 71-tooth gear. Triplex ball bearings and one roller bearing support the bevel-pinion shaft. Duplex ball bearings and one roller bearing support the bevel-gear shaft in an overhung configuration.

A planetary mesh provides the second reduction stage. The bevel-gear shaft is splined to a sun gear shaft. The 27-tooth sun gear drives three or four 35-tooth planet gears, depending on the model. The planet gears mesh with a 99-tooth fixed ring gear splined to the transmission housing. Power is taken out through the planet carrier splined to the output mast shaft. The output shaft is supported on top by a split-inner-race ball bearing and on the bottom by a roller bearing. The overall reduction ratio of the main power train is 17.44:1.

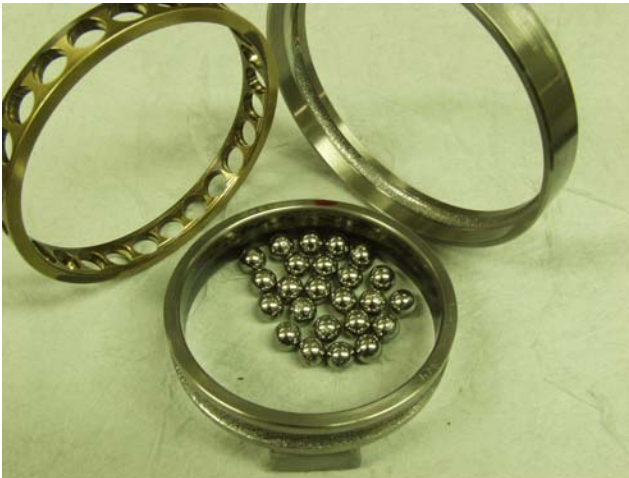
c) Failed Spiral-Bevel Gear  
Duplex Ball Bearing

After 33 hours of run time with data collection the transmission was disassembled, due to excessive chip detection indication and debris on the chip detector, and a spalled spiral-bevel gear duplex ball bearing was found (fig. 1c). A new bearing was installed and the transmission was cleaned and re-assembled. After an additional 39 hours of run time, the transmission was disassembled and a spalled spiral-bevel pinion triplex ball bearing was found (fig. 1d).

The oil debris accumulated mass measured by the oil debris sensor is shown in figure 3 for the duplex bearing failure. The dashed lines in figure 3 identify data sets that relate back to the crack propagation tests (Decker and Lewicki (2003)). Torque was at 150% during all of these tests. A spalled spiral-bevel gear duplex ball bearing was found at the end of data set 4-18. After reading 2755, a significant increase in accumulated debris occurred at reading number 2756. This also coincided with the test transmission chip detector indication of debris. At the end of the tests, over half of the bearing inner race, over half of the outer race, and most of the balls were damaged (fig. 1c).

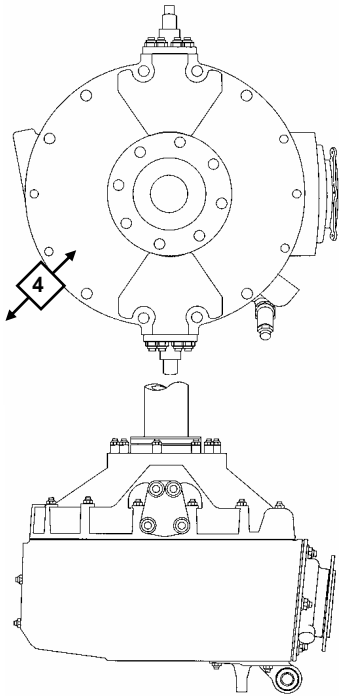
Vibration data was collected from accelerometers located on the transmission housing as shown in figure 2. For this analysis, only accelerometer A4 was used due to its proximity to the failed bearings. Torque was measured by a commercially available torque meter connected to the input shaft loop.

Figure 2.—Accelerometer Location on OH-58 Transmission Housing.

A theoretical framework of a data fusion model applied to transmission bearing damage detection is shown in figure 10. Envelope analysis is applied to the accelerometer installed on the transmission housing previously shown in figure 2. One important step in the data fusion process is the preprocessing of the sensor data to reduce the quantity of data and improve the quality of data prior to and during the feature extraction stage. An increase in the magnitude of the envelope data were used as the input into the fuzzy logic system. The accumulated mass threshold calculated from equation (1) is used as the feature for the oil debris sensor. The output is the state of the bearing.

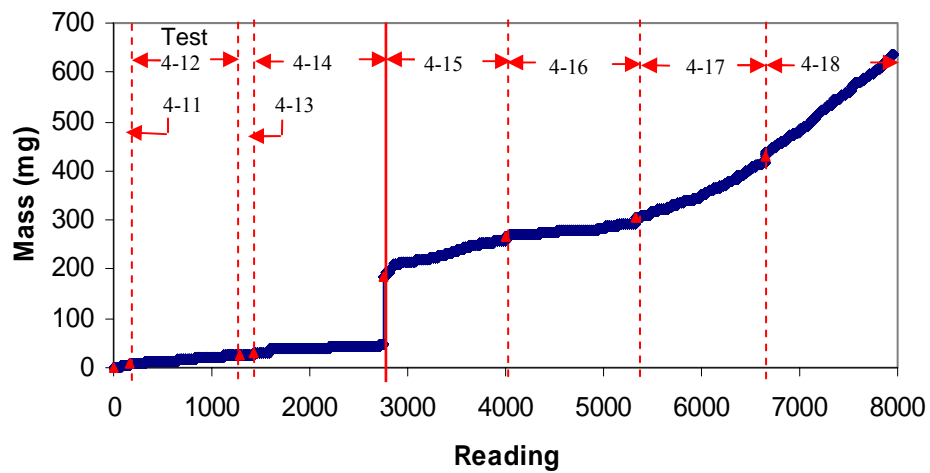
Figure 3.—Oil Debris Mass Measured By The Oil Debris Sensor During Duplex Bearing Failure.

The enveloped spectrum data for the duplex bearing failure was analyzed and is plotted in figure 6. The data shown, 4-12 average, 4-15 average and 4-18 average was taken at 3 different times during testing. Referencing figure 3, average 4-12, is the average spectrum during readings 436-445, average 4-15 is the average for readings 3983-4002, and average 4-18 is the average for readings 7945-7959. Note the time between readings was approximately 15 seconds. For figures 6, the triangles on the X-axes indicate the duplex bearing defect median frequency listed in Table 4  $\pm$  3Hz to account for frequency bandwidth and varying contact angles. The magnitude at the defect frequencies plotted in figure 7 increased significantly from test 4-12 to 4-15 and 4-18. Table 6 lists the multiplication factor increase in the envelope magnitude of the bearing defect frequencies from test 4-12 to test 4-15 and from test 4-12 to test 4-18. All of the bearing defect frequencies showed a significant increase at test completion. Results of this analysis indicate an increase in magnitude at these frequencies can be used as a bearing damage diagnostic tool.

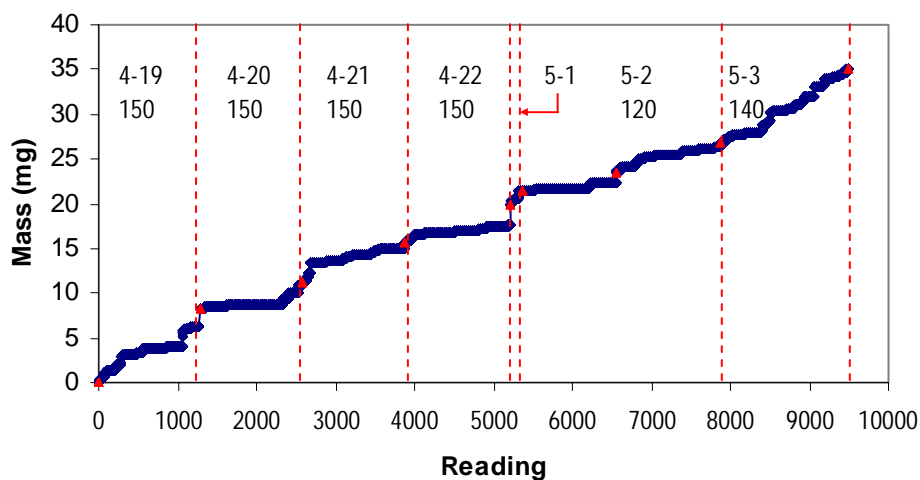
A spalled spiral-bevel pinion triplex ball bearing was also found at the end of another set of experiments. The oil debris accumulated mass measured by the oil debris sensor is shown in figure 4 for the triplex bearing failure. The dashed lines in figure 4 also identify data sets that relate back to the crack propagation tests. Torque was 150% during the data sets 4-19 through 4-22, 120% for 5-1 and 5-2, and 140% for 5-3. A constant increase in debris occurred during this test. At the end of the test, a small portion of the outer bearing race was damaged (fig. 1d). A mass alarm value of 197 mg was calculated for the triplex bearing. This mass value was never achieved during testing. The manufacturer also indicates a mass warning value of 0.1 times the mass alarm, 19.7 mg. This level was reached at reading 5216.

Figure 4.—Oil Debris Mass Measured By The Oil Debris Sensor During Triplex Bearing Failure.

The enveloped spectrum data for the triplex bearing failure was analyzed and is plotted in figure 8. The data shown, 4-19 average, 4-21 average, 4-22 average, and 5-3 average was taken at 4 different times during testing. Referencing figure 4, average 4-19, is the average spectrum during readings 745-749, average 4-21 is the average for readings 3227-3231, average 4-22 is the average for readings 4532-4536, and average 5-3 is the average for readings 9339-9343. The triangles on the X-axis indicate triplex bearing defect frequencies listed in Table 3  $\pm 3\text{Hz}$  for FTF and BSF,  $\pm 5\text{Hz}$  for BPFO and BPFI to account for frequency bandwidth and varying contact angles. The magnitude at the defect frequencies plotted in figure 9, increased significantly from test 4-12 to 4-15 and 4-18. Table 7 lists the multiplication factor increase in the envelope magnitude of the bearing defect frequencies from test 4-19 to tests 4-21, 4-22, and 5-3. All of the bearing defect frequencies showed a significant increase at test completion. Results of this analysis indicate an increase in magnitude at these frequencies can be used as a bearing damage diagnostic tool. It should also be noted that only outer race damage occurred during this test, and this feature showed the largest increase in magnitude. This feature also indicated the outer race bearing damage before the oil debris warning limit previously discussed.

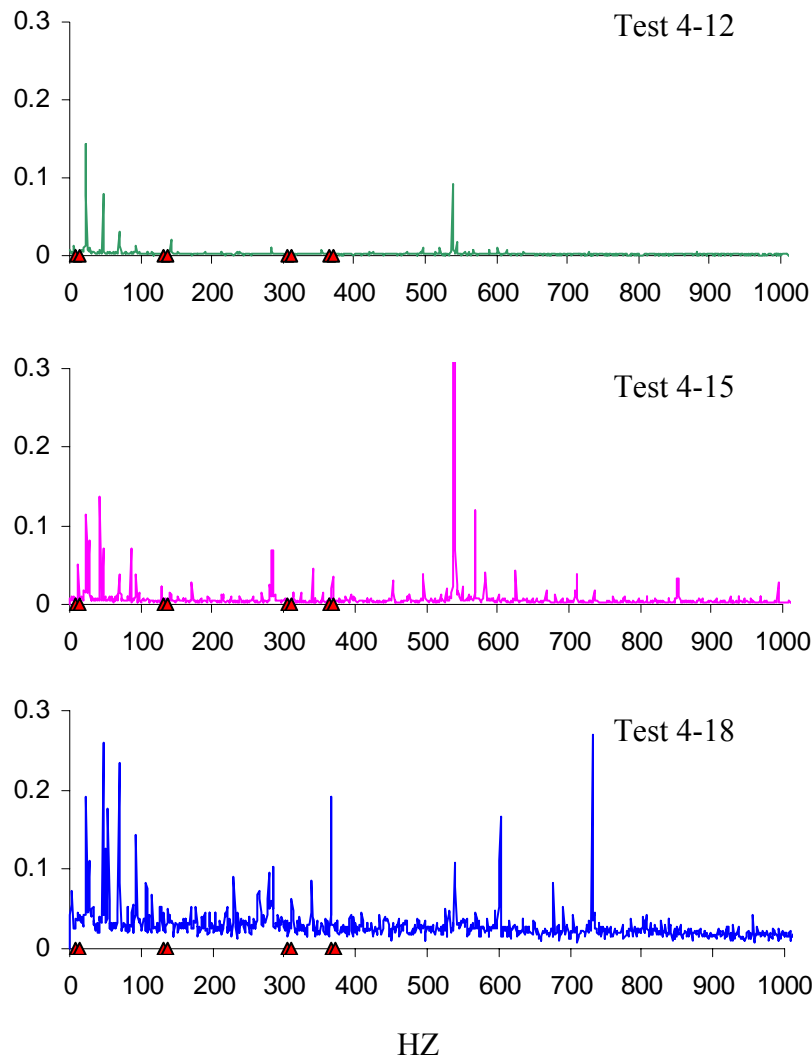
Figure 6.—Magnitude Of Envelope Analysis Of Duplex Bearing.

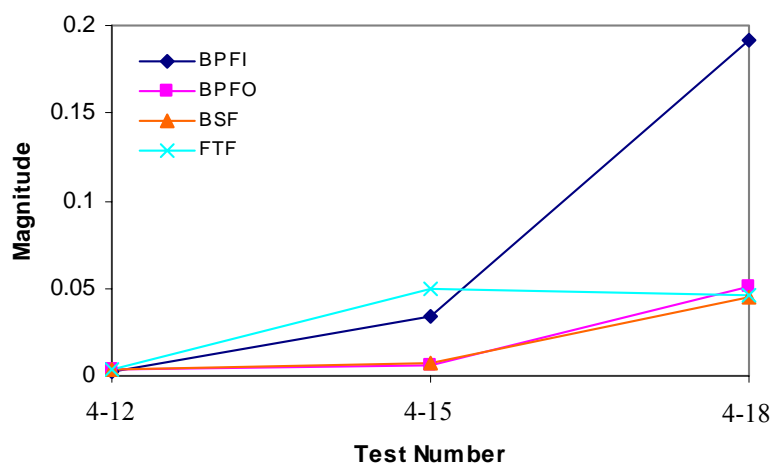
Figure 7.—Duplex Bearing Increase In Defect Frequencies.

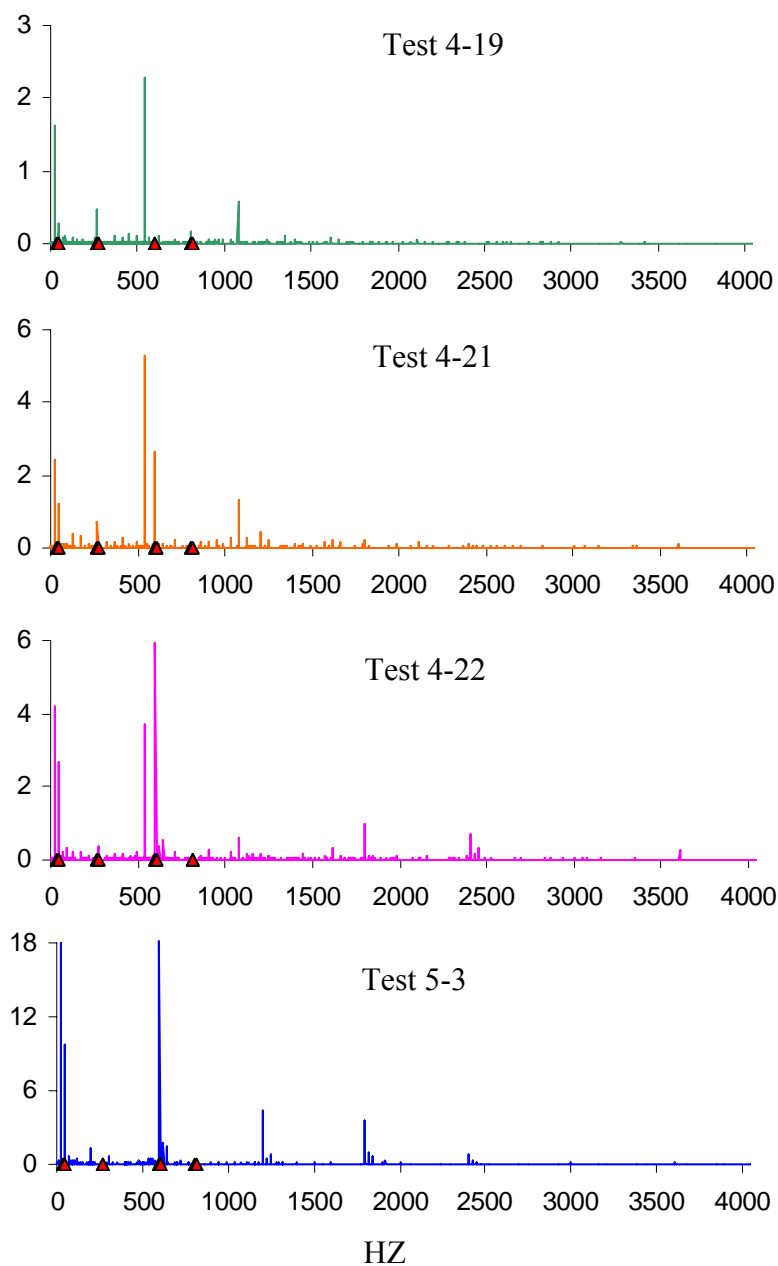
Figure 8.—Magnitude Of Envelope Analysis Of Triplex Bearing.

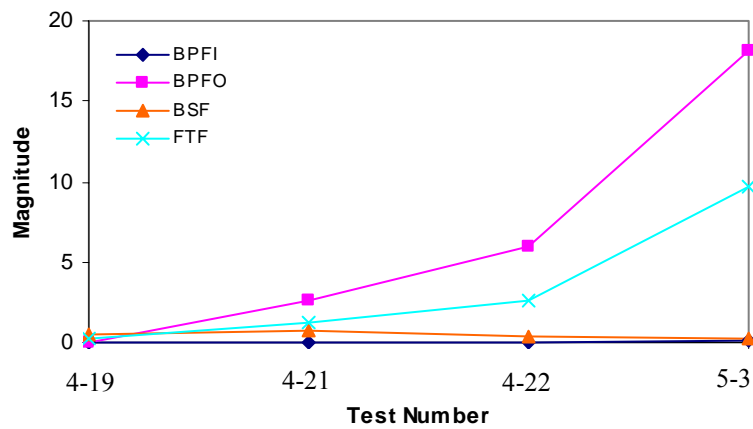
Figure 9.—Triplex Bearing Increase In Defect Frequencies.
